Watershed Restoration FACTSHEET:

Alta Vista Tributary Project

Alta Vista Tributary Subwatershed

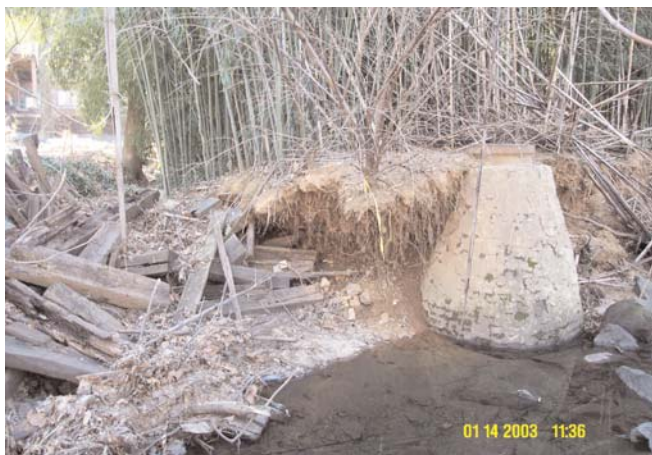
Heavy stormwater flows have eroded banks, exposed sanitary sewer utilities, damaged private property and undercut trees.

Exposed sanitary sewer lines will be reburied, and exposed manholes will be protected with rock. All utility work will be completed in coordination with the WSSC. Damaged and eroded storm drain outfalls will also be repaired.

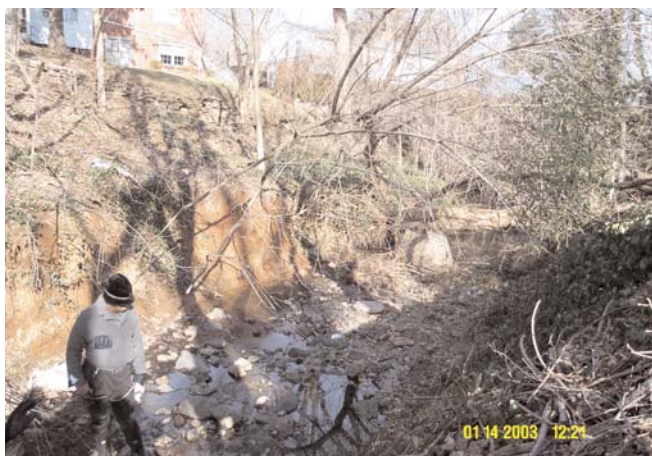
The Alta Vista Tributary is characterized by steep banks very close to vulnerable residential properties.
